21 MY Rogue – ECU Configuration Error Code C9004 with Windows 7

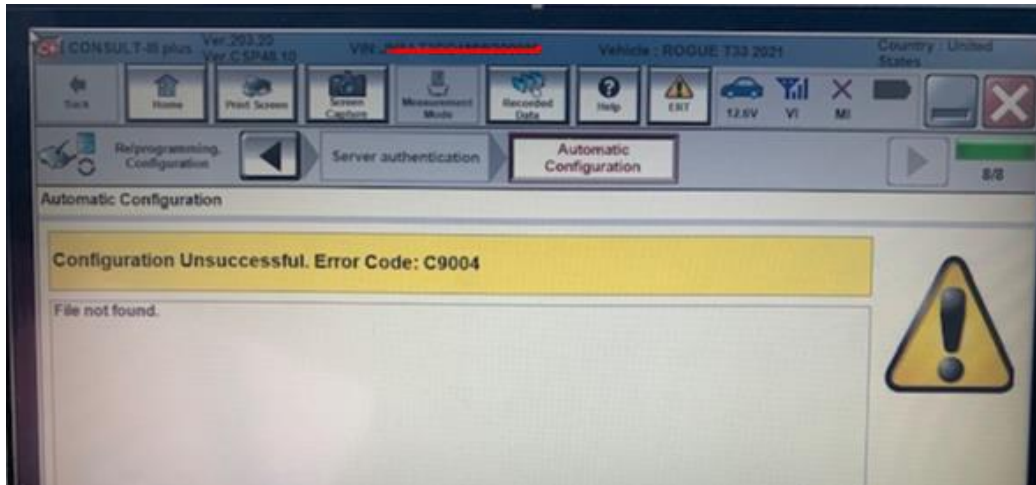
1. The 2021 MY Rogue uses an on-line method for configuring ECUs (if required). If a Windows 7 CONSULT PC does not have the latest Windows updates, the following error may occur during the configuration writing.

2. Use a Windows 10 CONSULT PC to complete the configuration and/or apply the latest Windows 7 updates to current PC.
3. To update your Windows 7 PC go to Control Panel/System and Security/Window Update. Click "Check for updates" and install the updates when prompted. This process may take up to 3 hours to complete.
